Lead Service Line Inventory Hybrid Work Plan

**Records Review, Field Inspections, Interpolation,
and Stratified Random Sampling**

**Created by: Carpinteria Valley Water District
Engineering Department**

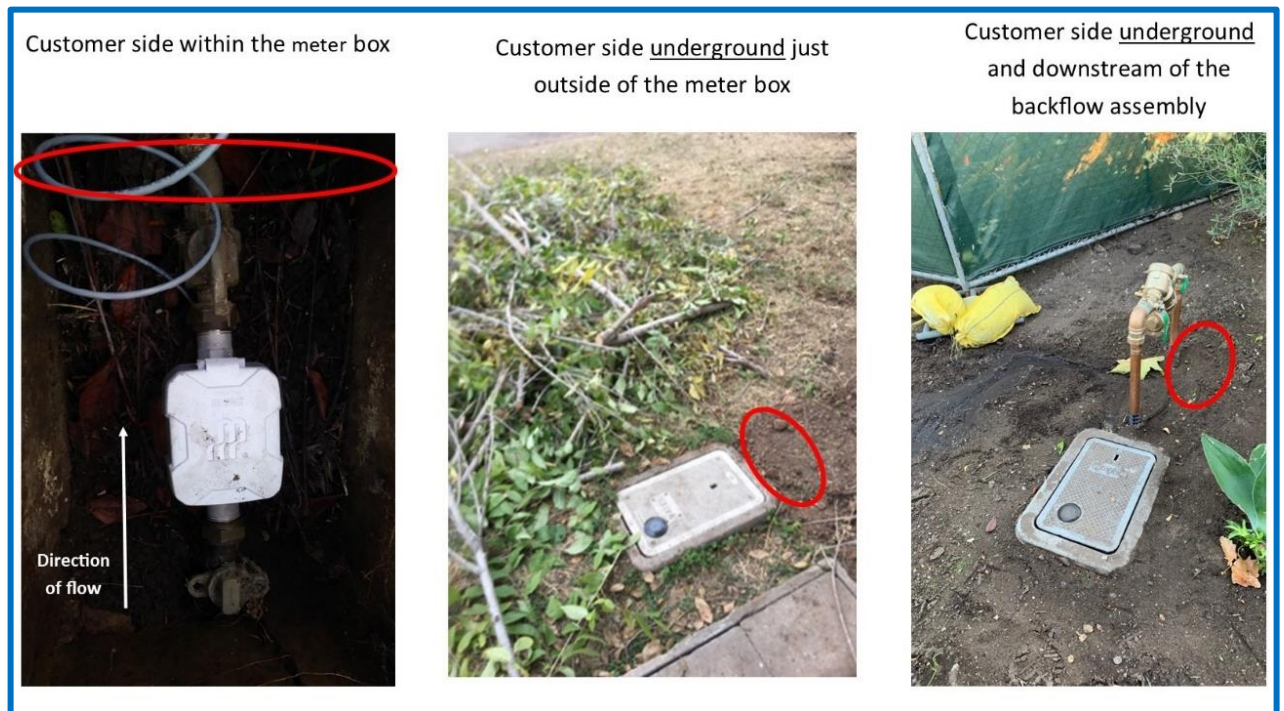
If a backflow assembly is installed within 1-5 feet from the water meter, field staff have the *option* to either get the customer's pipe material in the water meter box or to expose the pipe material underground downstream (on the customer side) of the backflow assembly. If the customer's pipe is not visible in the box and there is no backflow device installed, then CVWD staff will dig just outside of the water meter box on the customer side and test the pipe at that location. These options are displayed in **Figure 1**.

Figure 1. Options for Testing the Customer's Pipe Material

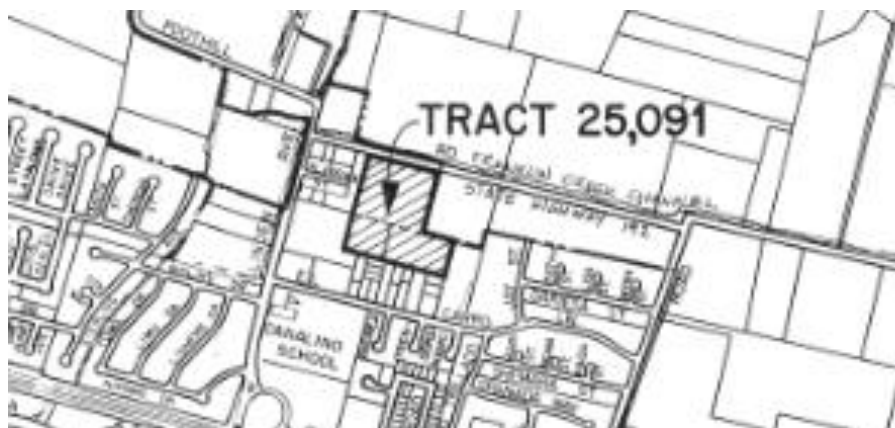
The District does not have institutional knowledge of or construction documents showing the material used for the installation of the meters serving the properties depicted in **Figure 5** and **Figure 6**. The as-built document for the development indicates that meters were installed according to what was “typical”, but no service line material was referenced.

Figure 5. Tract overview map provided on As-Built for the development

There are a total of 55 individually metered properties in this proposed interpolation area shown in the map in **Figure 5** and **Figure 6**. There are a total of 55 residential meters and 1 home owner’s association (HOA) landscape meter for a total of 56 meters. There are no known service line repair records for these properties and the material is unknown on both sides for all 56 meters.

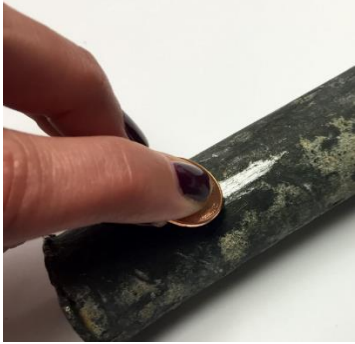
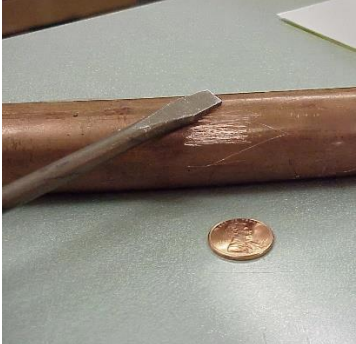
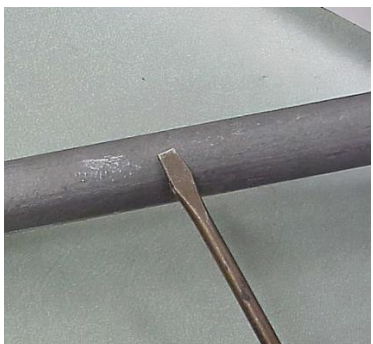
APPENDIX A: Field Test Guidance - Visual, Scratch Test, Magnet Test, and Lead Test

Type of Pipe	Lead Pipe	Copper Pipe	Galvanized Pipe	Plastic Pipe
Reference Image
